4. TITLE (and Subtitle) The deep sea moorings fishbite problem		5. TYPE OF REPORT & PERIOD COVERED Technical
7. AUTHOR(s) H.O. Berteaux, Dr. Bryce Prindle & Lt. Daniel May		6. PERFORMING ORG. REPORT NUMBER WHOI Contr. 6494

The Deep Sea Moorings Fishbite Problem\*

H.O. Berteaux<sup>1</sup>, Dr. Bryce Prindle<sup>1</sup>, and Lt. Daniel May<sup>2</sup>

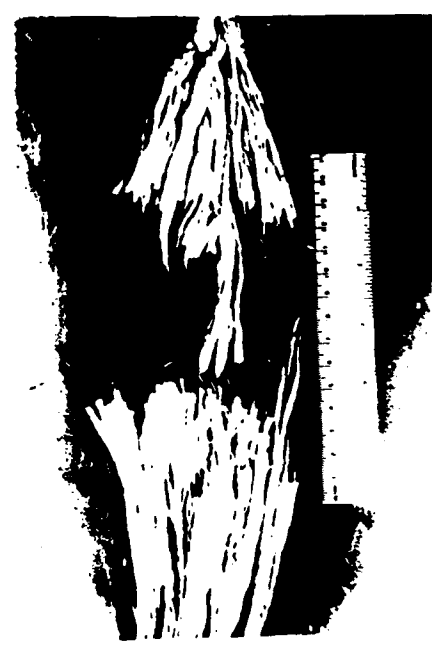
Often parted ends show effects of both cutting and tensile break, e.g. truncated ends on the cut yarns and a "ponytail" appearance on yarns broken by tension, as shown in Figure 2.

Figure 2. 1 1/2" Nylon rope damaged by fishbite (23).

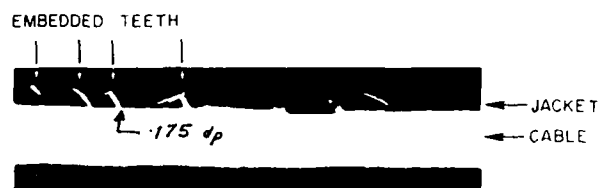
Finding teeth or tooth fragments in a plastic jacket is of course the ultimate confirmation that fishbite has occurred. Occasionally, whole teeth may be found, but more often there are only fragments identified as bits of tooth. As evidenced in Figure 18, the use of X-ray can help confirm the presence of embedded teeth.

Figure 18. An X-ray of a polyethylene jacketed line revealing shark teeth in situ.

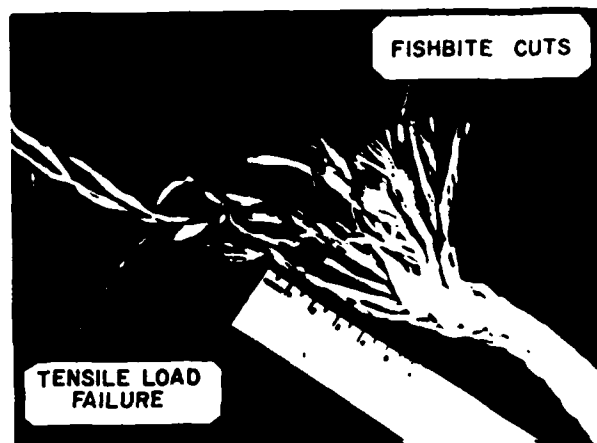
Fishbites inunjacketed fiber lines may show up as sharply cut yarns or strands which often stick out from the side of a rope. If the line has parted in service, and only a fag end is retrieved, it will often be found that many of the yarns have truncated ends, which indicates cutting by a sharp instrument, such as fish teeth. At the same time, the ends of a few yarns may have a 'ponytail' appearance, which is indicative of tensile failure. Such a pattern is characteristic of a line which had most of its yarns cut by fishbites, leaving only a few yarns to sustain the tensile load (Figure 19).

Figure 19. Synthetic fiber rope typical fishbite failure.

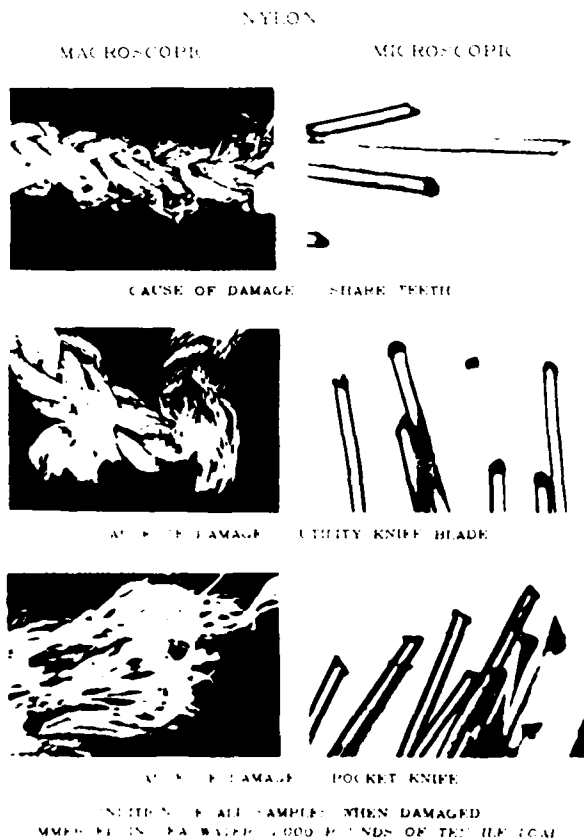
These steps are presented in detail, together with an extensive collection of macroscopic and microscopic signatures of parted fiber ends in Berteaux and Prindle (5). These comparison standards reproduce the causes and modes of damage most likely to be encountered in mooring line service (cutting, tension, abrasion, etc...) and encompass rope materials commonly in use (Dacron, Nylon, Polypropylene and Kevlar). An example of these signatures is shown in Figure 20.
